Renovation and extension sports center, Gstaad

2018

Gstaad has made its sports center fit for the future. In addition to the construction of a wellness area, the wooden support structure of the indoor swimming pool was extensively renovated. Timbatec analyzed its condition and defined the renovation measures.

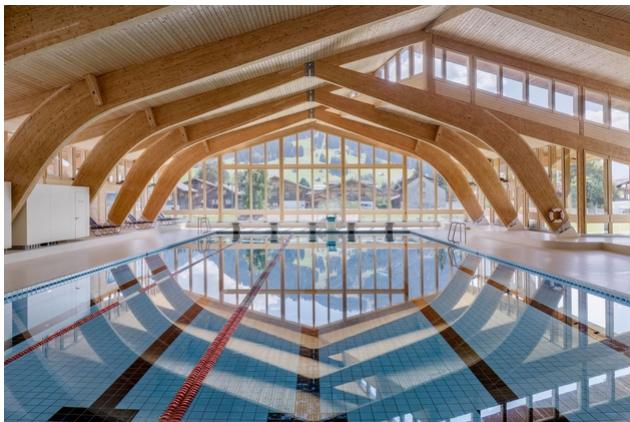
Impressive dimensions: supporting structure of the indoor swimming pool

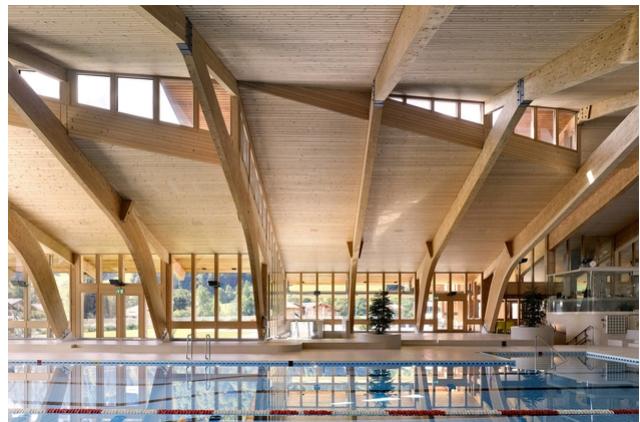
Between the trusses was renewed acoustic paneling

In order to reinforce individual trusses, lamellas made of glulam were glued on. In addition, the roof was thermally renovated. The boarding between the trusses was removed, the roof was insulated from the inside and provided with a new formwork. Timbatec was responsible for quality assurance of the refurbishment work and also for fire protection for the entire project.

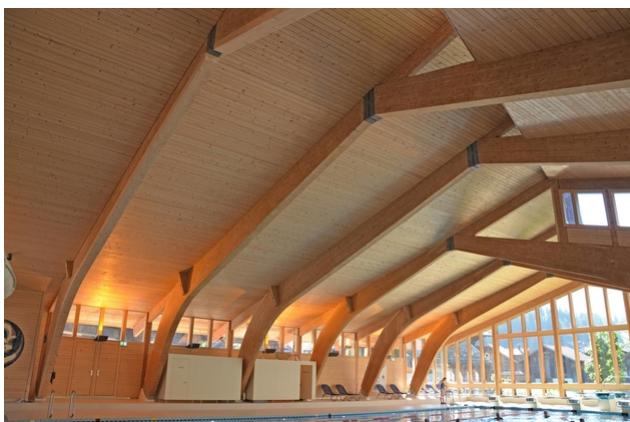
The beam on the far left is additionally reinforced with slats

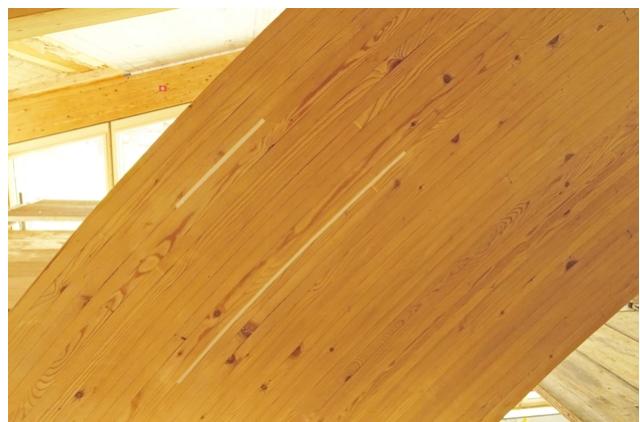
Detailed view of a rehabilitated adhesive joint

The Gstaad indoor swimming pool, built in 1971, is the oldest indoor swimming pool in Switzerland with a three-hinged arch supporting structure made of glulam. The pool has been a listed building for some time. The dimensions of the construction are impressive. The supporting structure consists of three-hinged arch trusses with spans of up to 34.2 meters and cross sections between 20 x 110 cm and 35 x 135 cm. But age has left its mark. Building technology, the drains as well as the building structure were partly outdated. In addition, cracks had appeared in the main supporting structure of the roof. Timbatec received the order to investigate the cracks. They were recorded and documented with a total station. It was found that certain cracks were so deep that the statics were no longer guaranteed. It was also found that the load on the main girders was too high in some areas. Crack repair was therefore necessary on the girders. The cracks were cut free, cleaned and adhesive was injected to close them.
